USACERL Special Report 96/19  
December 1995

# **The Barksdale Air Force Base Historic District**

## **Project Overview, History, and Maintenance Plan**

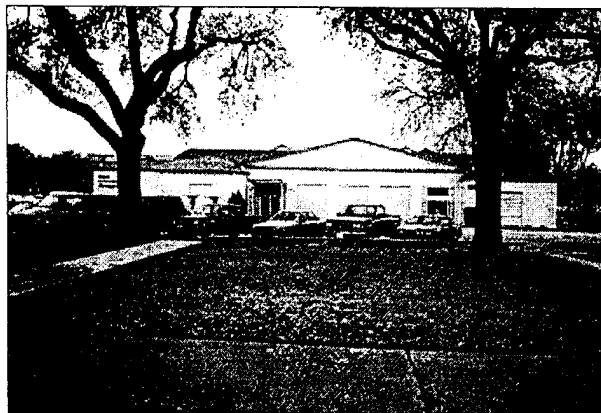
### Front Elevation

Originally, the floor area was 8683 square feet. Subsequent lean-to additions built before 1941 have gained historic significance. The original building was rectangular in plan with the main elevation facing what is now Barksdale Blvd W. The front elevation had two pavilions flanking a colonnade that had formed the front porch of the Postal Exchange. The pavilions had flat clay tile hipped roofs and the colonnade had a flat roof with parapet wall. The main space was spanned by a flat clay tile gambrel roof. The original windows were 8 light casements with a multi-light transom, and the doors were one panel wood multi-light.
